**RE: Drinking Water Sampling – Miami Township School District**  
34520 North Highway 41  
Miami, MO 65344  
**Project Number: 923319**

Drinking Water Assessment  
Miami R-1 Township School District

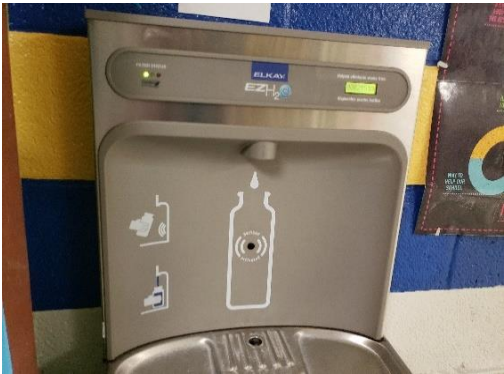
ID:	319-MTS-01	Location:	North Entry Hall	
Photo:

Manufacturer:	Elkay	
		Description		
		Drinking Fountain Bottle Filler		
		Date Sampled:	9/25/2023	By:
Result:		<1.0	ug/l	
Recommended Action:

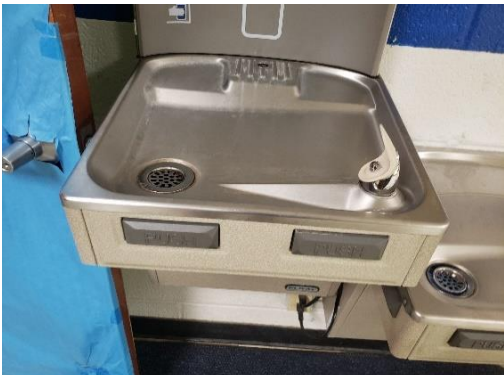
ID:	319-MTS-02	Location:	North Entry Hall	
Photo:

Manufacturer:	Elkay	
		Description		
		Drinking Fountain Bubbler (Left)		
		Date Sampled:	9/25/2023	By:
Result:		<1.0	ug/l	
Recommended Action:

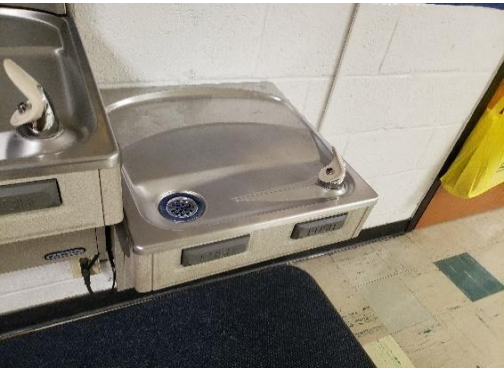
ID:	319-MTS-03	Location:	North Entry Hall	
Photo:

Manufacturer:	Elkay	
		Description		
		Drinking Fountain Bubbler (Right)		
		Date Sampled:	9/25/2023	By:
Result:		<1.0	ug/l	
Recommended Action:

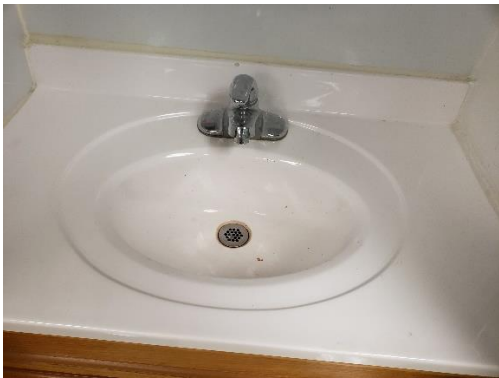
ID:	319-MTS-04	Location:	Science, CL-5		
Photo:

Manufacturer:	Unknown		
		Description			
		Classroom Sink			
		Date Sampled:	9/25/2023	By:	NJ
		Result:	3.1	ug/l	
Recommended Action:

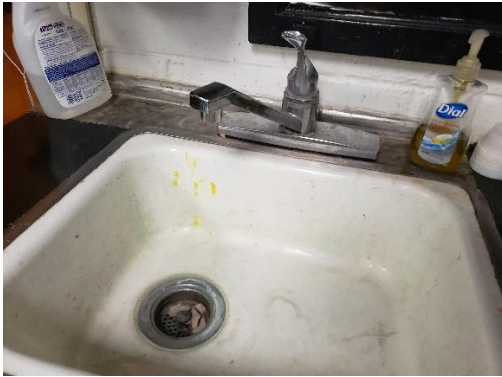
ID:	319-MTS-05	Location:	Art, CL-8		
Photo:

Manufacturer:	Unknown		
		Description			
		Classroom Sink			
		Date Sampled:	9/25/2023	By:	NJ
		Result:	9.7	ug/l	
Recommended Action:		<b>Replace Fixture/Unit and Resample</b>

In accordance with the requirements set forth in Missouri Bill 681/662, fixtures exhibiting lead concentrations above 5 ppb must be remediated by replacement of lead-containing pipes, solder, fittings or fixtures with lead-free components, or the school shall install filtration at each point where water enters the building until such time as the source can be remediated. If installing a filter is not feasible, the school shall provide purified water at each outlet inventoried.

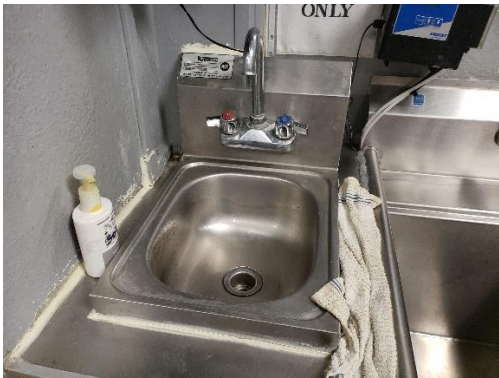
ID:	319-MTS-07	Location:	Kitchen		
Photo:

Manufacturer:	Krowne		
		Description			
		Hand Washing Sink			
		Date Sampled:	9/25/2023	By:	NJ
Result:		3.8	ug/l		
Recommended Action:

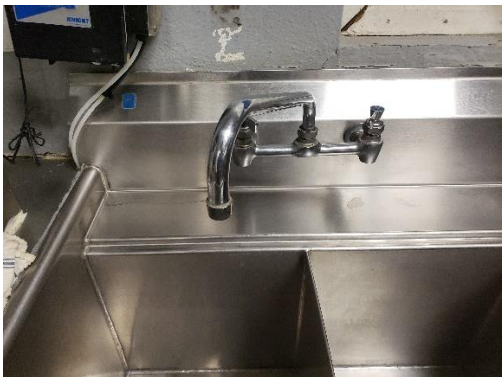
ID:	319-MTS-08	Location:	Kitchen		
Photo:

Manufacturer:	Unknown		
		Description			
		Dish Washing Sink			
		Date Sampled:	9/25/2023	By:	NJ
Result:		2.4	ug/l		
Recommended Action:

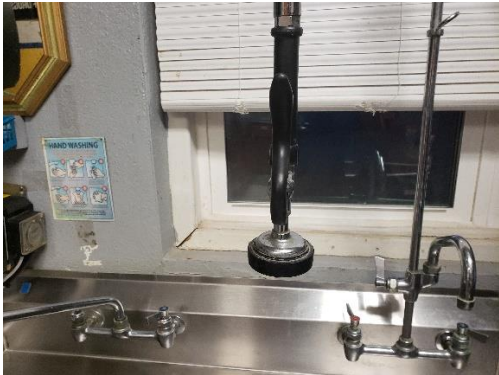
ID:	319-MTS-09	Location:	Kitchen		
Photo:

Manufacturer:	Unknown		
		Description			
		Kitchen Dish Sprayer			
		Date Sampled:	9/25/2023	By:	NJ
Result:		1.1	ug/l		
Recommended Action:

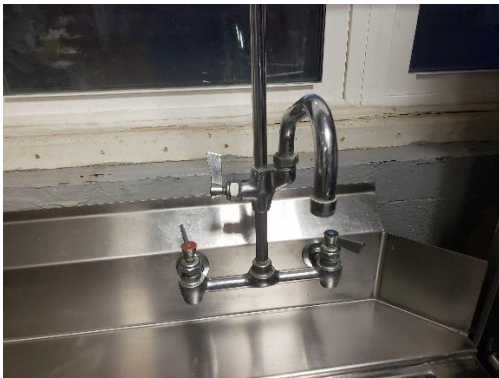
ID:	319-MTS-10	Location:	Kitchen	
Photo:

Manufacturer:	Unknown	
		Description		
		Kitchen Sprayer Faucet		
		Date Sampled:	9/25/2023	By:
Recommended Action:		Result:	264.0	ug/l
<b>Replace Fixture/Unit and Resample</b>

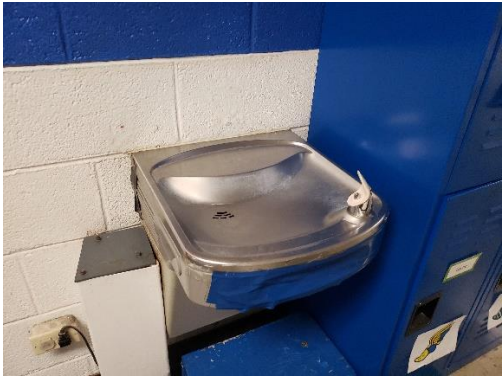
ID:	319-MTS-11	Location:	Main Hallway	
Photo:

Manufacturer:	Elkay	
		Description		
		Drinking Fountain Bubbler (Standalone, Out of Order)		
		Date Sampled:	9/25/2023	By:
Recommended Action:		Result:	N/A	ug/l

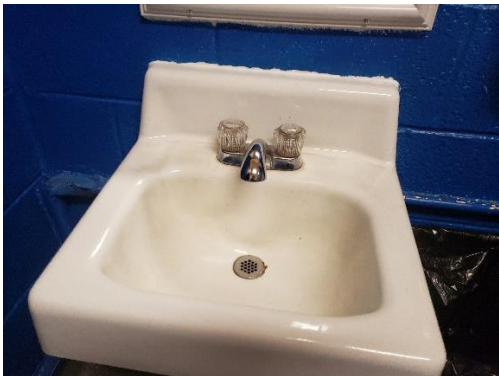
ID:	319-MTS-12	Location:	South Girls' Restroom	
Photo:

Manufacturer:	Delta	
		Description		
		Restroom Sink (Left)		
		Date Sampled:	9/25/2023	By:
Recommended Action:		Result:	8.0	ug/l
<b>Replace Fixture/Unit and Resample</b>

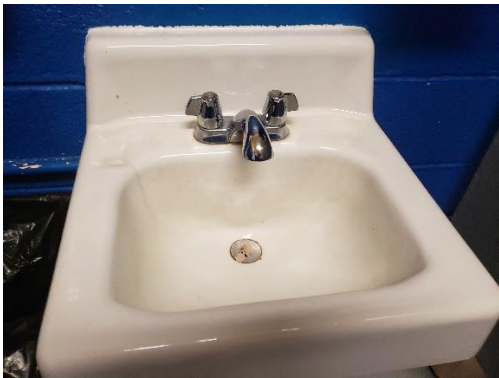
ID:	319-MTS-13	Location:	South Girls' Restroom	
Photo:

Manufacturer:	Delta	
		Description		
		Restroom Sink (Right)		
		Date Sampled:	9/25/2023	By:
Recommended Action:		Result:	14.9	ug/l
<b>Replace Fixture/Unit and Resample</b>

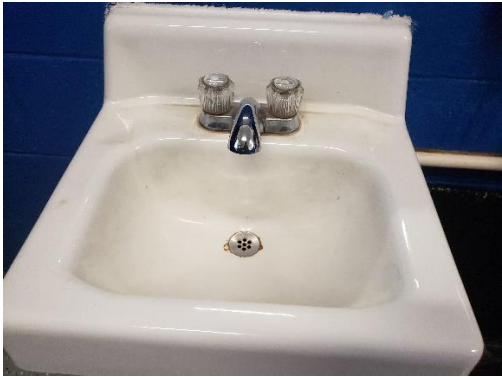
ID:	319-MTS-14	Location:	South Boys' Restroom	
Photo:

Manufacturer:	Delta	
		Description		
		Restroom Sink (Left)		
		Date Sampled:	9/25/2023	By:
Recommended Action:		Result:	5.5	ug/l
<b>Replace Fixture/Unit and Resample</b>

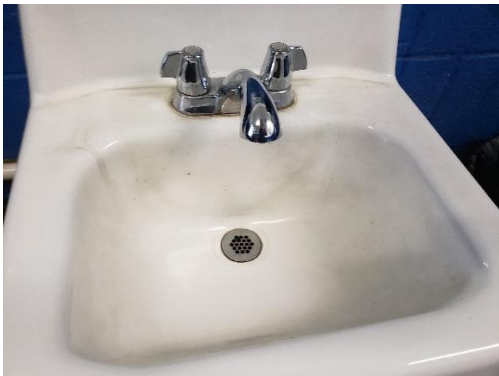
ID:	319-MTS-15	Location:	South Boys' Restroom	
Photo:

Manufacturer:	Delta	
		Description		
		Restroom Sink (Right)		
		Date Sampled:	9/25/2023	By:
Recommended Action:		Result:	3.4	ug/l

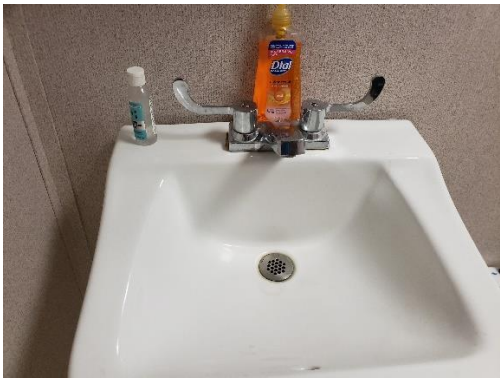
ID:	319-MTS-16	Location:	5th Grade Classroom	
Photo:

Manufacturer:	Unknown	
		Description		
		Restroom Sink		
		Date Sampled:	9/25/2023	By:
		Result:	3	ug/l
Recommended Action:

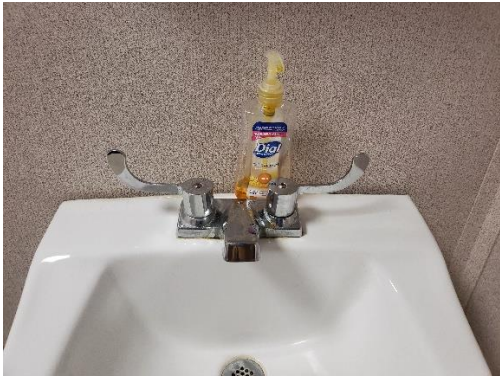
ID:	319-MTS-17	Location:	4th Grade Classroom	
Photo:

Manufacturer:	Unknown	
		Description		
		Restroom Sink		
		Date Sampled:	9/25/2023	By:
		Result:	2.6	ug/l
Recommended Action:
